River Ythan SLA Report March to May 2023

SLA Activities/ Willow Bank Repair/Glen of Ebrie/ Grid Ref JN 93614 40148

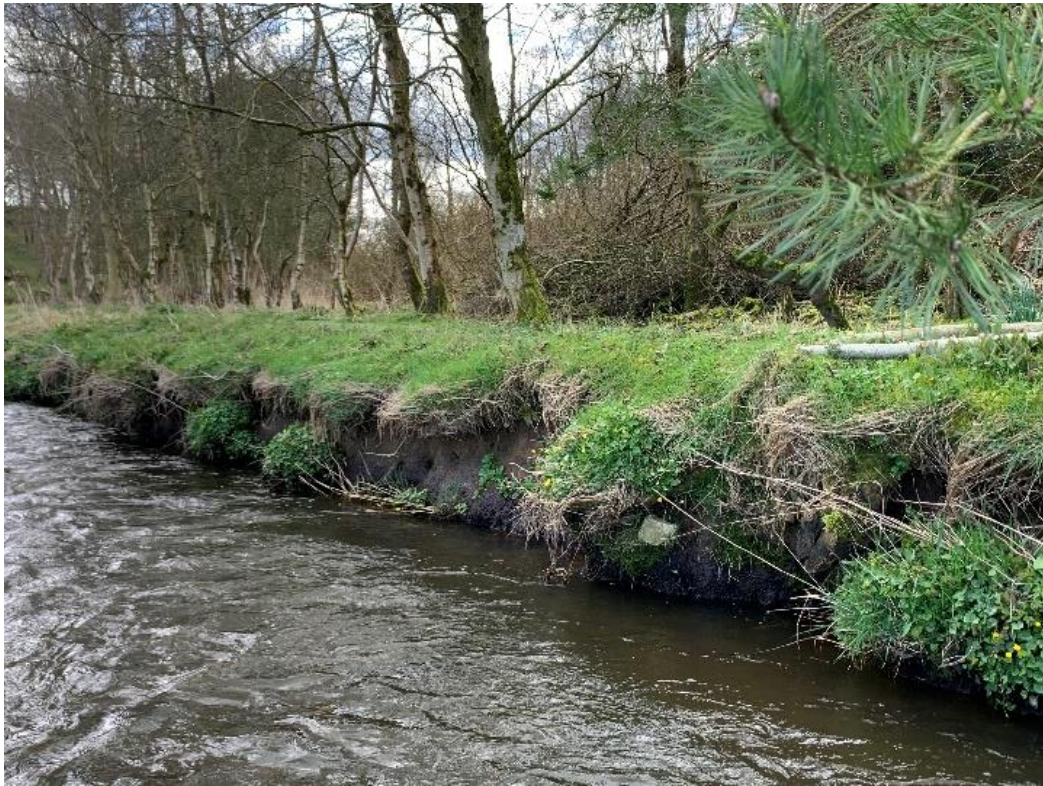
Fig 1, Before works commenced on the eroded bank repair.

It took 7 days to complete the willow bank repair and hitting bedrock when posting was at times challenging, this meant continually repositioning the posts and starting once again. The salmon Redds 30m below the bank repair, were still visible and suggesting that no redd washout occurred during the winter floods. Now that this eroded section of the stream has been stabilised, it will prevent heavy silt deposits from smothering the bed of the burn. I have added pictures below before works commenced and after the repair was completed.

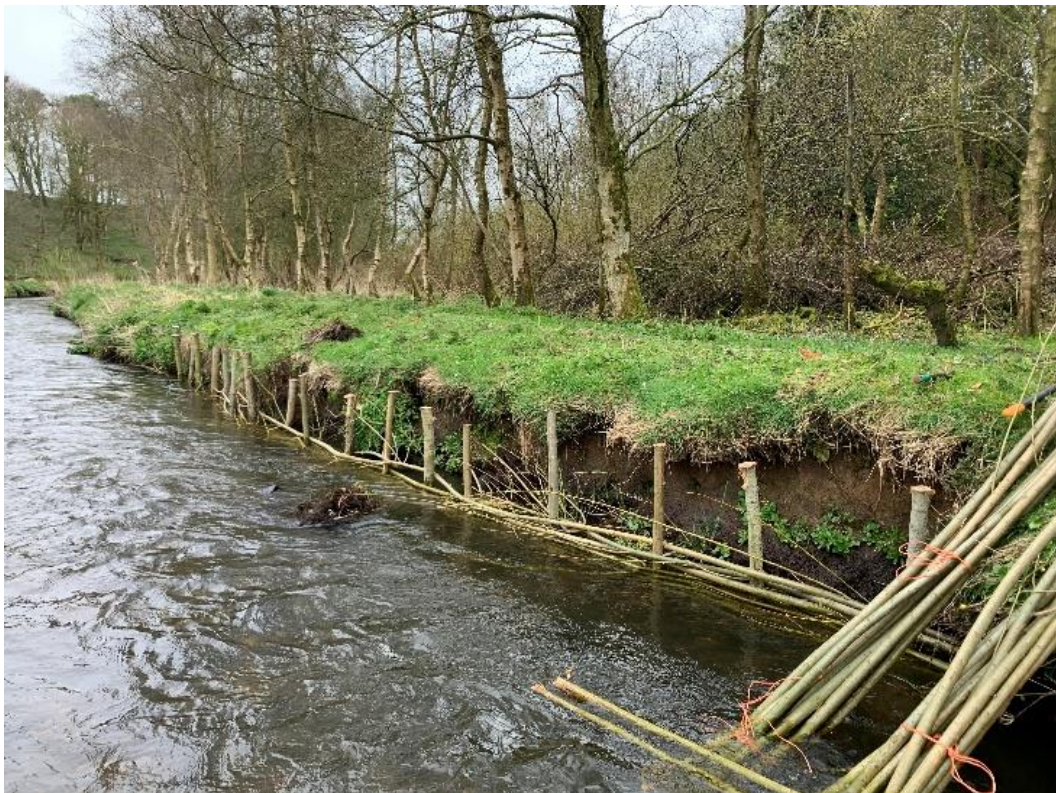
Fig 2, During bank stabilization repair below.

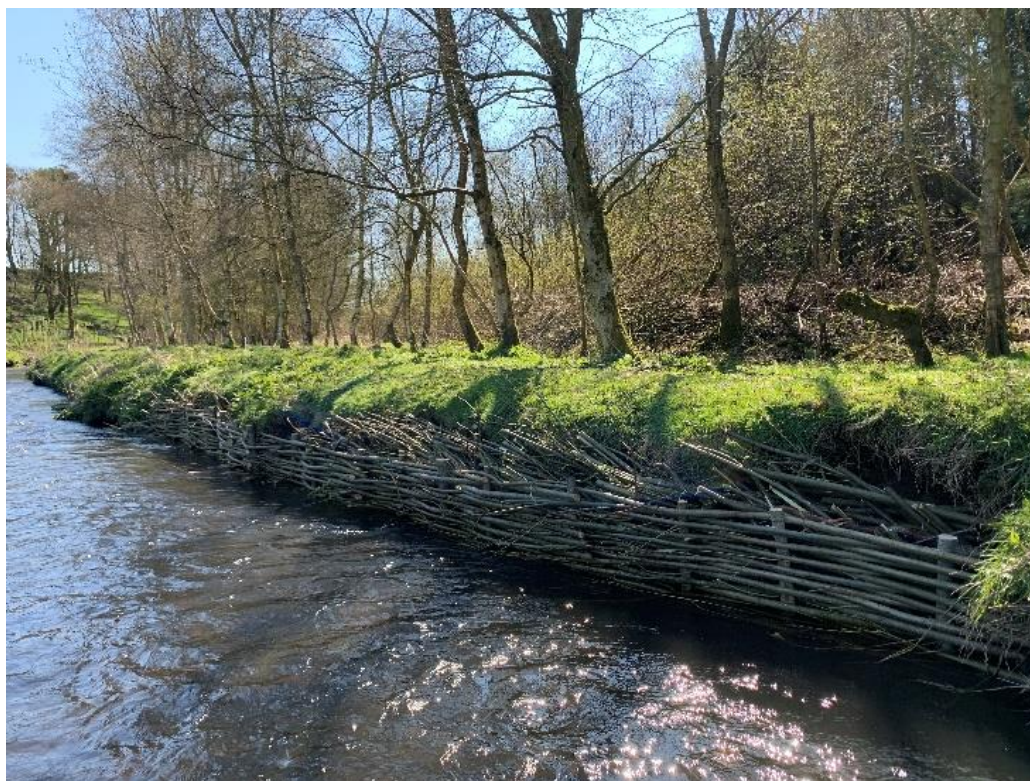
Fig 3, below showing completed Willow bank repair.

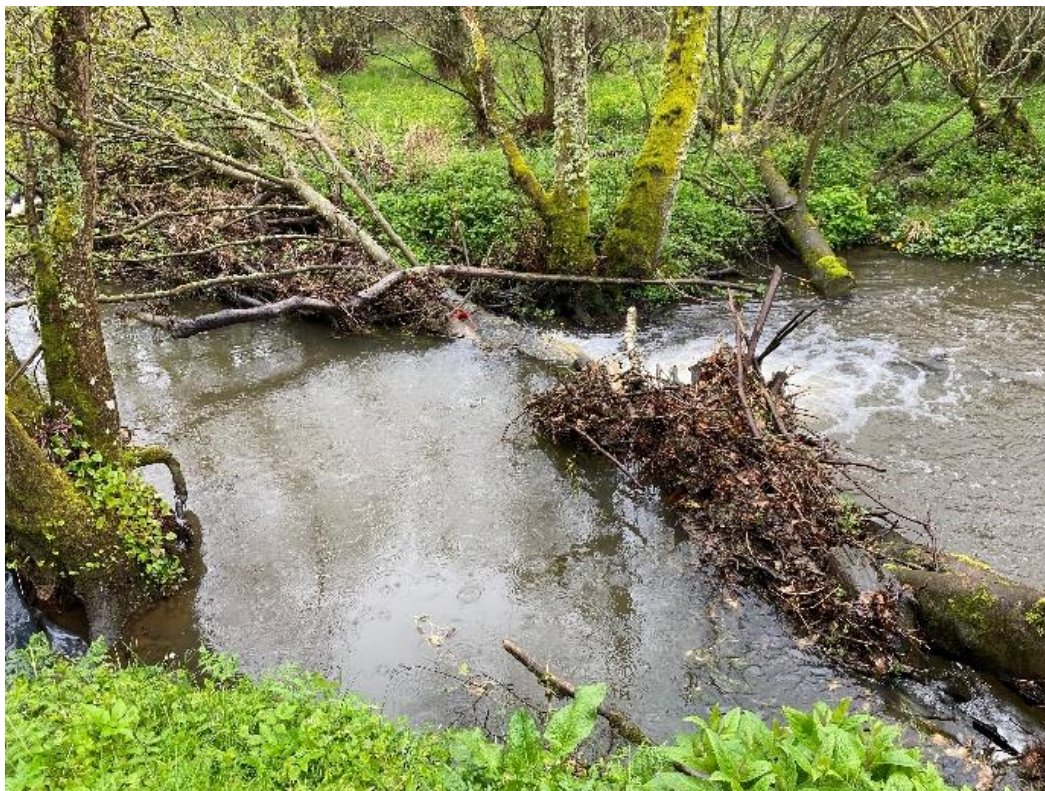
Date	Stream Name	Grid Reference	Type of Obstacle	Time Used	comments
8/5/2023	Fordoun Burn	NJ 73373 36520 Upstream of Rothie Vale	Fallen Tree	2 hours	Although this obstruction is covering the entire width of the stream, and debris is collecting around it, Smolts and other fish species would still be able to migrate underneath/over the obstruction at the time of my visit.
8/5/2023	Fordoun Burn	NJ 75077 37515	Fallen Tree	2 hours	Fallen wind blown tree partially in stream but not causing obstruction at this time.

Fig 4, fallen tree above Rothie Vale below.

These two 'Obstacles' found will be closely monitored and if found to be causing significant obstruction to fish passage, will be partially eased to allow migration, see images below.

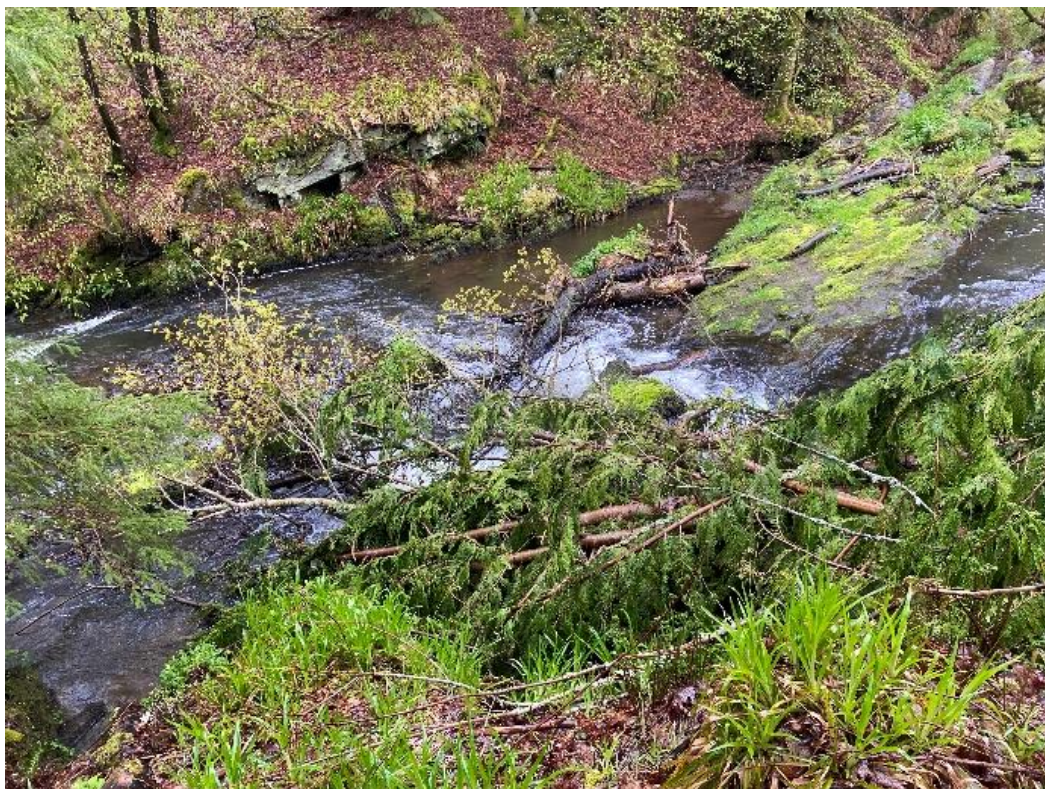
Fig 5, Windblown tree Grid Ref 75077 37515 below.

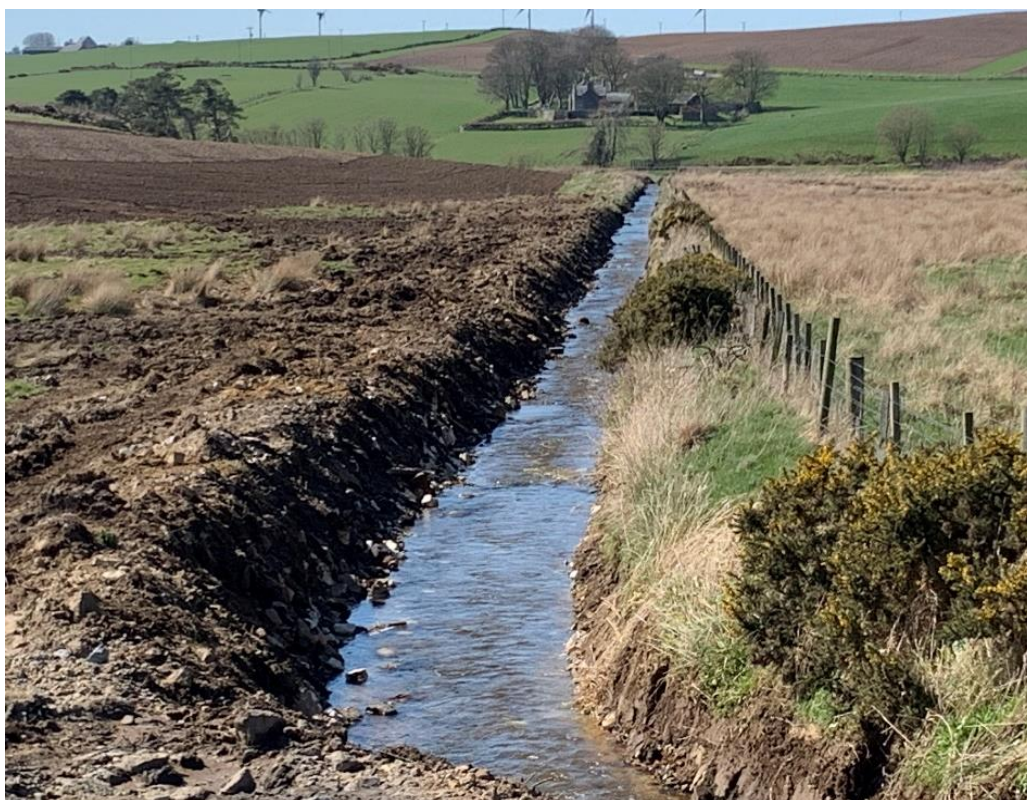
On the 18th of May I came across a small tributary, the Fortrie burn a tributary of the Ebrie burn that had sadly been dredged, pictures below. Location of this incident is directly below the road bridge on the A948 Ellon to Auchnagatt road, Grid reference NJ 93855 39715. Approximately 500 meters down to confluence with the Ebrie burn was dredged of all surface substrate and bankside vegetation. I contacted SEPA and explained what I had found. On the 26th of May I gave a statement to SEPA Inspector Mr Mark Gracey who is handling the incident, at this time they are gathering evidence to take forward. Due to data protection, they would not indulge further information on the person responsible at this time.

Fig 6, Fortrie Burn below.
